R-1767

Exhibit 9 - Photograph [R-1767]

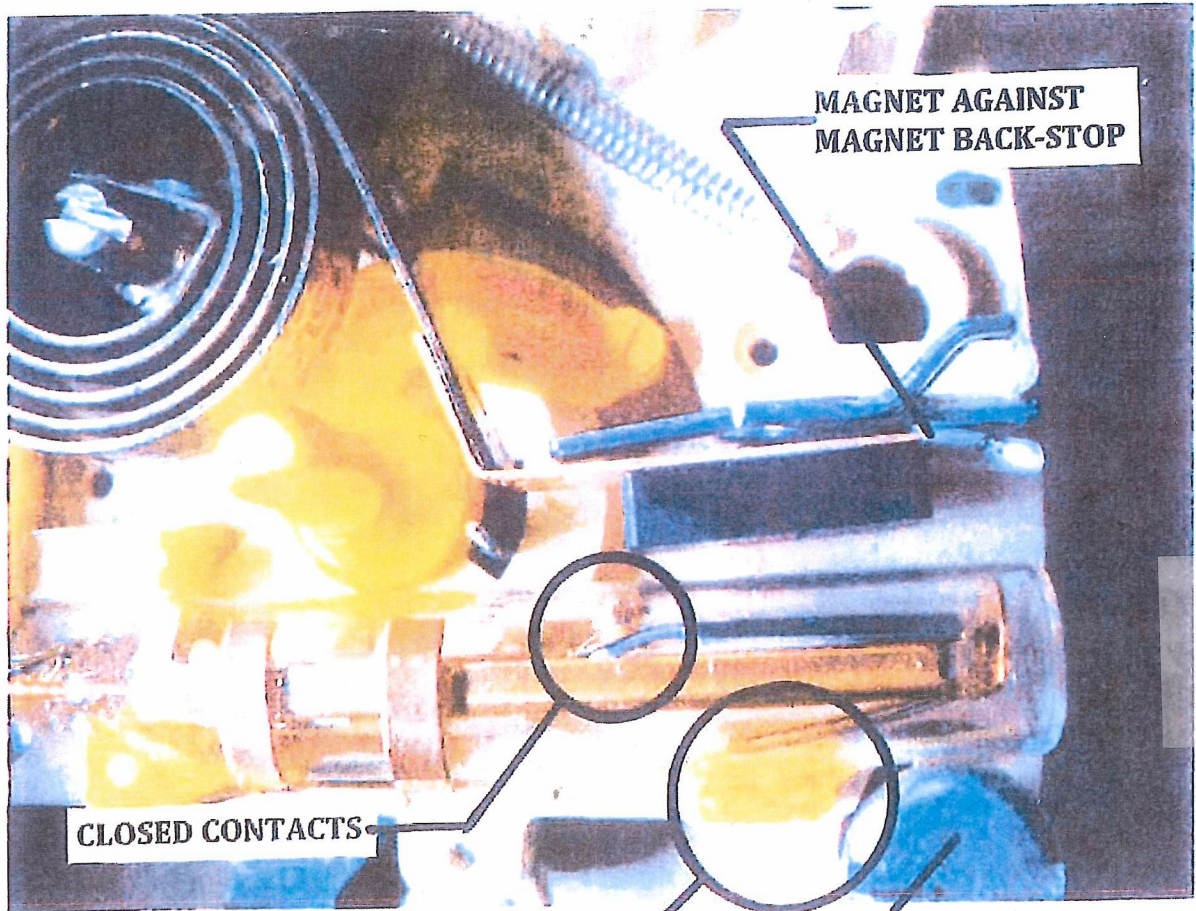
Exhibit #9

MAGNET AGAINST  
MAGNET BACK-STOP

CLOSED CONTACTS

ADHESIVE BREAK & VIAL  
DISPLACEMENT CAUSED  
BY AND HELD BY HEAD OF  
THIRD SCREW

OVER-SIZED HEAD  
OF THIRD SCREW
